## PROPERTY INSPECTION REPORT

**Prepared for: Real Client**

**Concerning: 1234 Anystreet Houston, TX**

**Date: 11/08/2007**

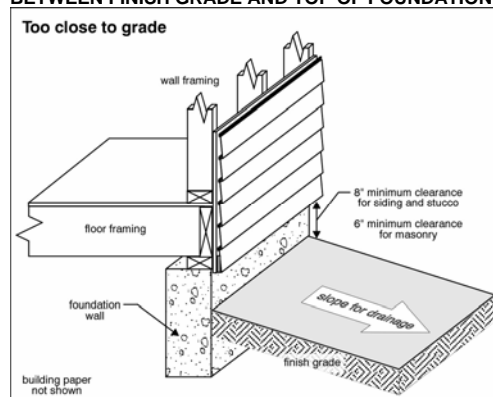
- Recommend removing planter boxes adjacent to house.
- Lower soil at rear (master bedroom) to maintain proper clearance.

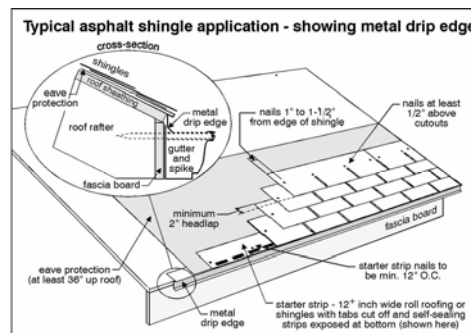
- Type: Single layer composition shingles over OSB decking.
- Minor trim rot observed at various locations. Recommended repainting and localized trim replacement as needed.

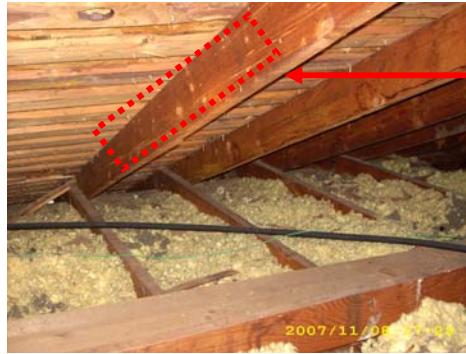
- Approximately 6-inches of fiberglass insulation. Insulation improvements may prove cost effective depending on the term of ownership.
- Observed (two) rafters in the main attic were observed to be slightly cracked and should be re-supported, i.e. add "scab" 2 x 6 to the affected part of the rafter(s). In my opinion, this is not a major structural concern as it is very limited (only observed 2 rafters w/ cracks) and is a relatively simple repair and should be done as necessary to maintain long-term integrity.

This rafter is at the rear side of the attic adjacent to the hallway access. Another was observed at the front attic adjacent to HVAC equipment.

- Recommend adding purlin bracing at 4-ft intervals to maintain long-term integrity and reduce roof sag.

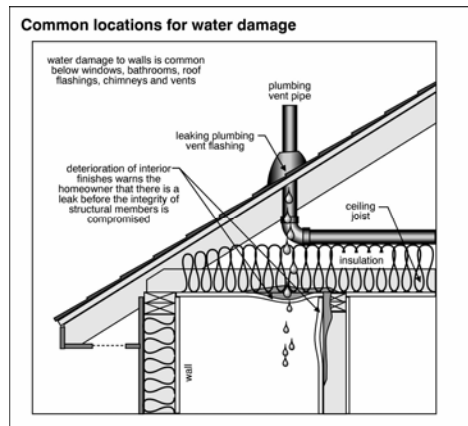
- Stains were observed in the ceiling at various locations (hallway, family room, dining room) indicating possible previous leaks. However, a moisture meter did not reveal the presence of active moisture at the time of inspection.

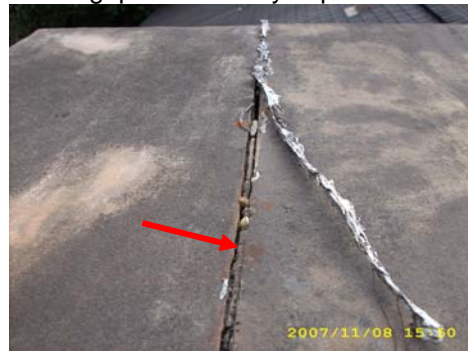
- Type: Masonry firebox w/ gas lighter
- Seal gaps in masonry cap on roof.

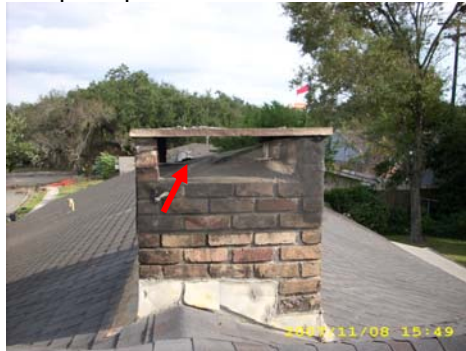
- Repair spark arrestor/vermin screening at roof level.

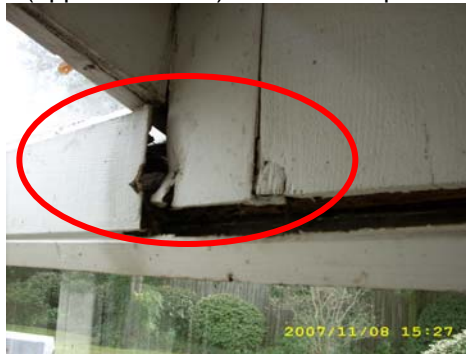
- The enclosed patio at the rear has wood rot and previous termite damage (appears to leak). Localized repairs should be undertaken as necessary.

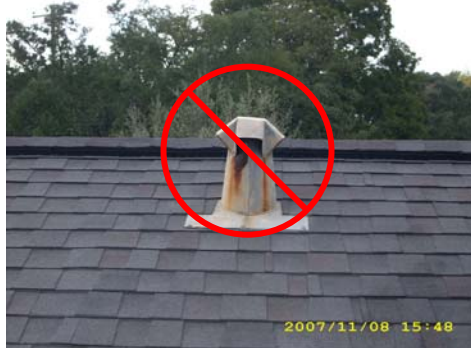
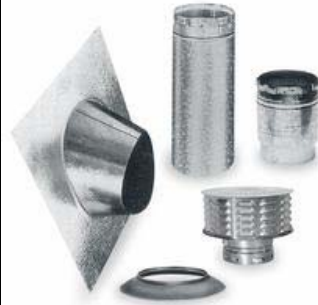
- Flame(s) observed for color and pattern. Unit(s) tested for evidence of carbon monoxide and gas leaks and are considered serviceable unless otherwise noted.
- Vent termination assembly does not meet current standards.

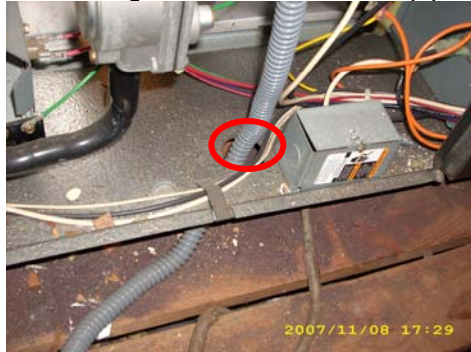
- The flex gas line should be hard piped at the point of entry at the gas furnace.

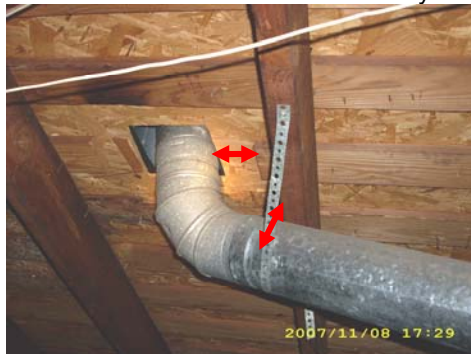
- The blower has slight vibration which should be further evaluated when servicing is performed.
- The vent pipe requires a minimum 1-inch clearance from combustibles. The roof deck should be trimmed away and/or the vent pipe adjusted as necessary.

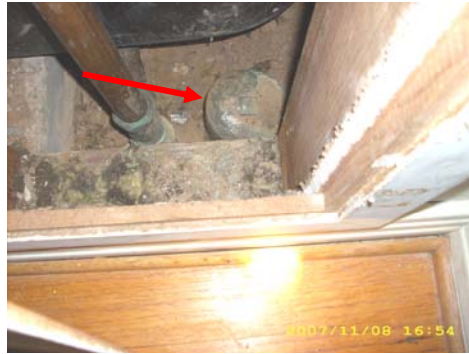
- Type: For the most part, the drain/waste piping within the house appears older. It may be prone to unexpected problems. Improvement is recommended on an as needed basis. NOTE: A PVC cleanout was observed at the rear exterior, indicating that previous repairs have been undertaken.
- The bathtub was observed to drain slowly, suggesting that an obstruction may exist, likely due to the old drum trap. It may be desirable to replace the drum trap with a "P" trap. A qualified plumber should be consulted.

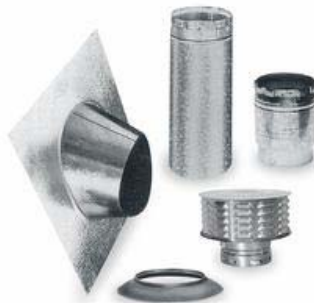
- Exterior closet: 40 gallon gas water heater (6 years old)
- Vent termination assembly does not meet current standards.

- Maintain 1-inch vent clearance from combustibles (i.e. sheetrock).

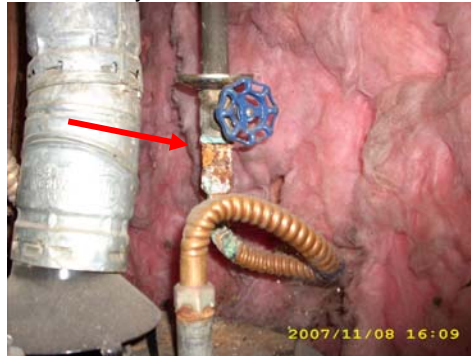
- Corrosion observed on cold supply should be repaired (clean or replaced) as necessary.
