FPE Panels – Hazard or Hype?

This article focuses on the controversy over inspecting and reporting Federal Pacific panels. It has been published in the magazine for the California Real Estate Inspection Association and in other technical journals.

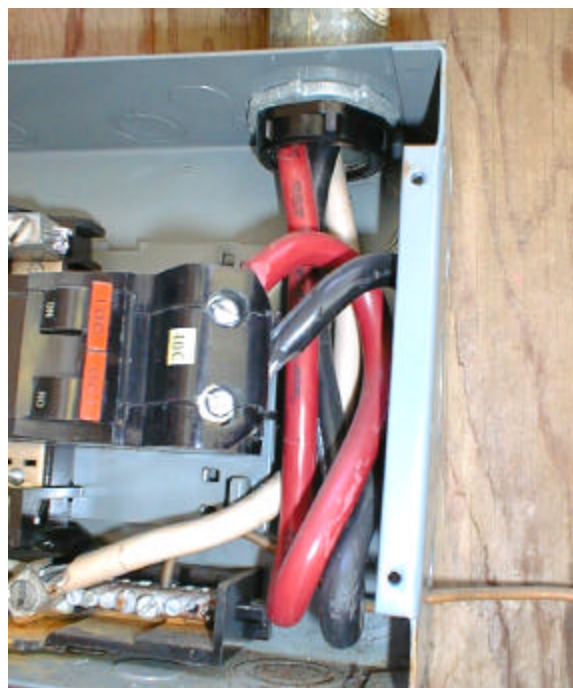
Figure 1 – Insufficient wire bending space

Several of the problems found with FPE panels are found in other brands of equipment of the same age. There is less gutter space in the panel than we find in modern equipment. The result is crowding of the wires in the panels. It is sometimes impossible to see all of the terminals in an FPE panel. The space for bending wires is also less than required in modern panels. The rules that proscribe minimum wire bending space are found in the National Electrical Code (NEC) in section 312.6 in the 2002 edition. Over the years, the required minimum space has increased, with the most significant changes in the 1981 NEC, near the very end of the days when FPE panels were made. FPE manufactured some panels with less clearance than the minimum code rules by installing the lugs at an angle, so the conductor was already parallel to the wall opposite the breaker terminal (figure 1). However, the bends shown in figure 1 defeat the purpose of the angled lugs, and the wire is bent too sharply.
