## PROPERTY INSPECTION REPORT

**Prepared for: Real Client**

**Concerning: 1234 Anystreet Houston, TX**

**Date: 11/08/2007**

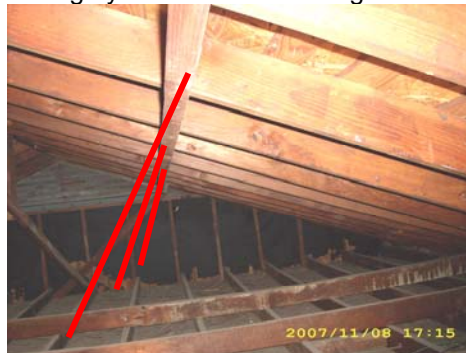
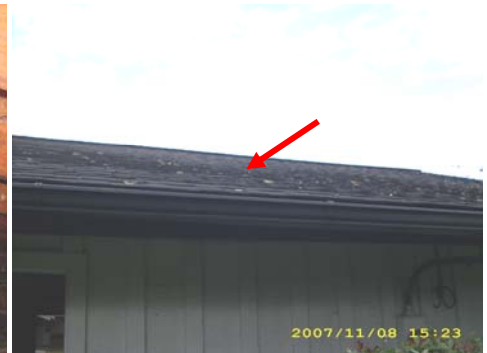
- Approximately 6-inches of fiberglass insulation. Insulation improvements may prove cost effective depending on the term of ownership.
- Observed (two) rafters in the main attic were observed to be slightly cracked and should be re-supported, i.e. add "scab" 2 x 6 to the affected part of the rafter(s). In my opinion, this is not a major structural concern as it is very limited (only observed 2 rafters w/ cracks) and is a relatively simple repair and should be done as necessary to maintain long-term integrity.

This rafter is at the rear side of the attic adjacent to the hallway access. Another was observed at the front attic adjacent to HVAC equipment.

- Recommend adding purlin bracing at 4-ft intervals to maintain long-term integrity and reduce roof sag.

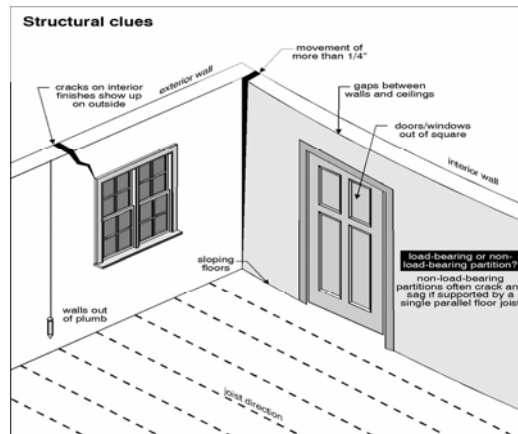
• Interior: Observation of the interior gypsum board ("drywall" or "sheetrock") wall and ceiling surfaces revealed standard workmanship for a structure of this age. This type of construction reflects any frame movement and/or foundation movement by cracking and/or joint distortions appearing in the surface. No evidence of significant distortions and/or cracks were observed at the time of inspection but cosmetic appearing distress indicators or imperfections may have been observed that are not individually noted. This condition would suggest that *major* foundation movement does not appear to have occurred *since the surfaces were last painted.*

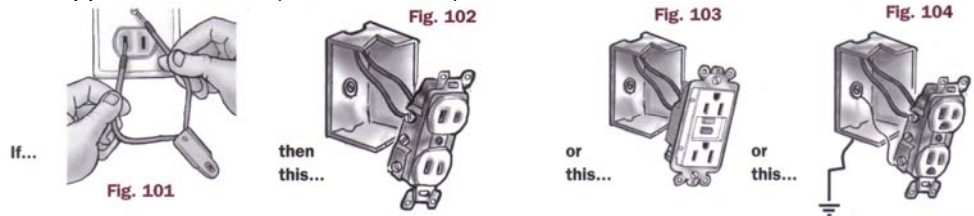
- Secure loose switch in utility room.
- Two prong (ungrounded) outlets were observed and should only be changed by an approved method (see illustration).

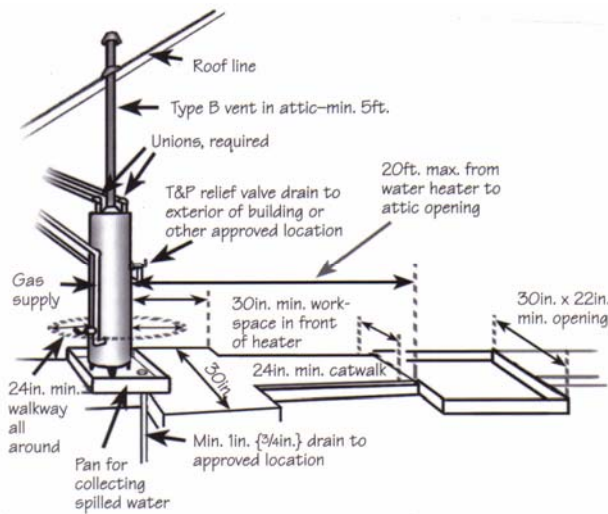
- Exterior closet: 40 gallon gas water heater (6 years old)
- Vent termination assembly does not meet current standards.
